NAS Part II Survey: Corduroy Road remnant near Brownstown, Michigan

Candidate: Daniel Harrison

Date: October 30, 2009

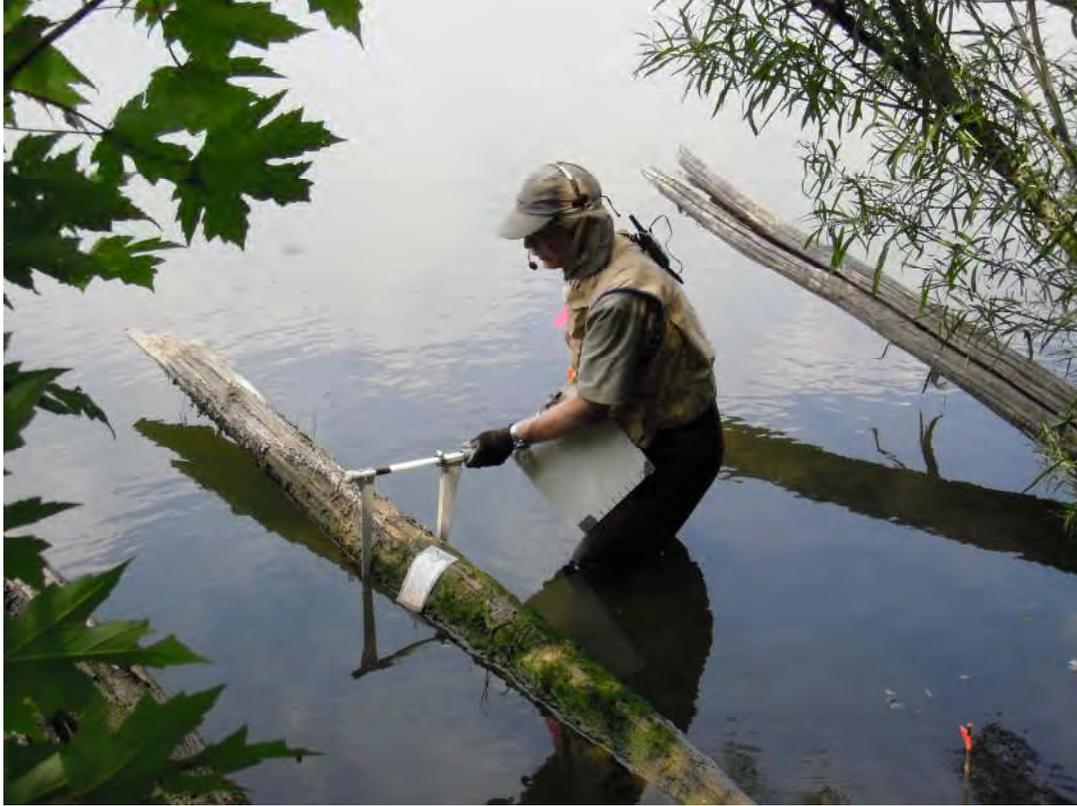
Fig. 1: Using calipers to measure the diameter of a log (Photo: M Holley)

A tree caliper was fabricated using a design from the forestry industry. Logs were measured in centimeters, at the point of greatest integrity nearest to the exposed end (Fig. 1). Badly split or shattered logs were measured, when possible, at a point where the trunk showed the greatest integrity. Most logs showed little variation in diameter along their exposed length;

this evidently reflects the designs of the road builders, who would be expected to select straight, uniform logs for the construction.

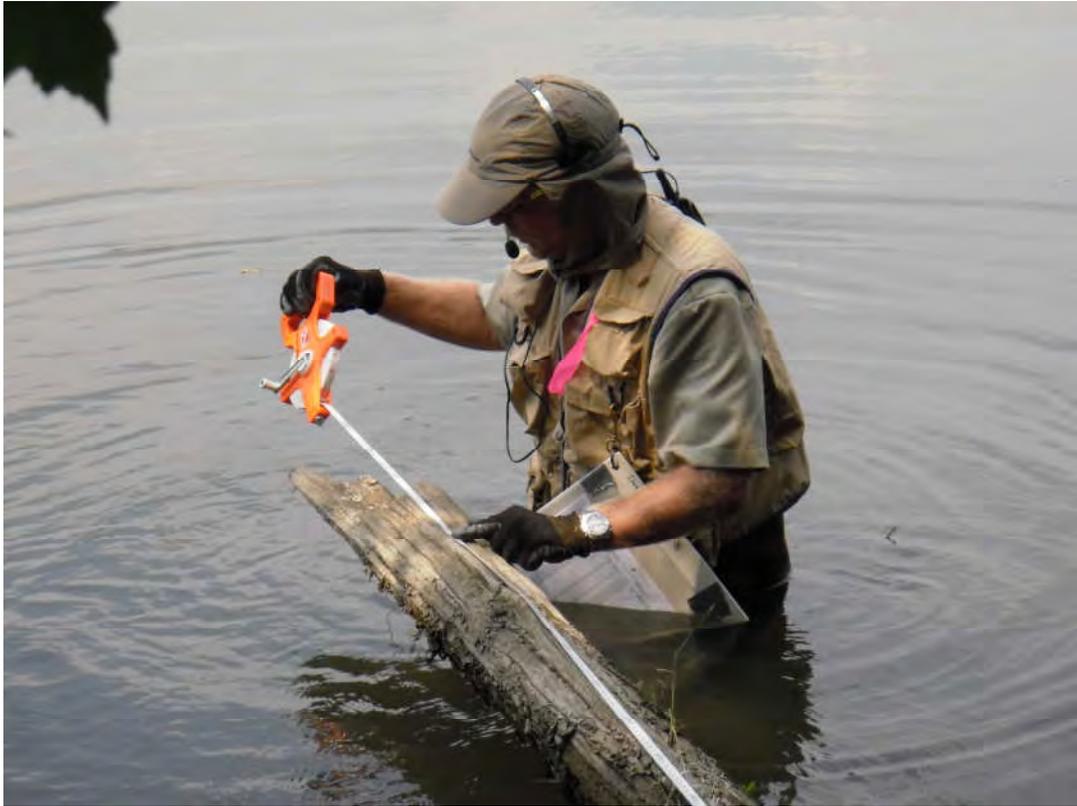
Fig. 2: Measuring the exposed length of a log (Photo: M Holley)

A standard surveyor's tape, marked in centimeters, was used to measure the distance from the point where the log emerged from the overburden (an angled embankment) to its outer endpoint (Fig 2). Deeply buried logs were occasionally encountered, where the outer end was buried as well. In such cases, this was noted and the exposed length measured accordingly.

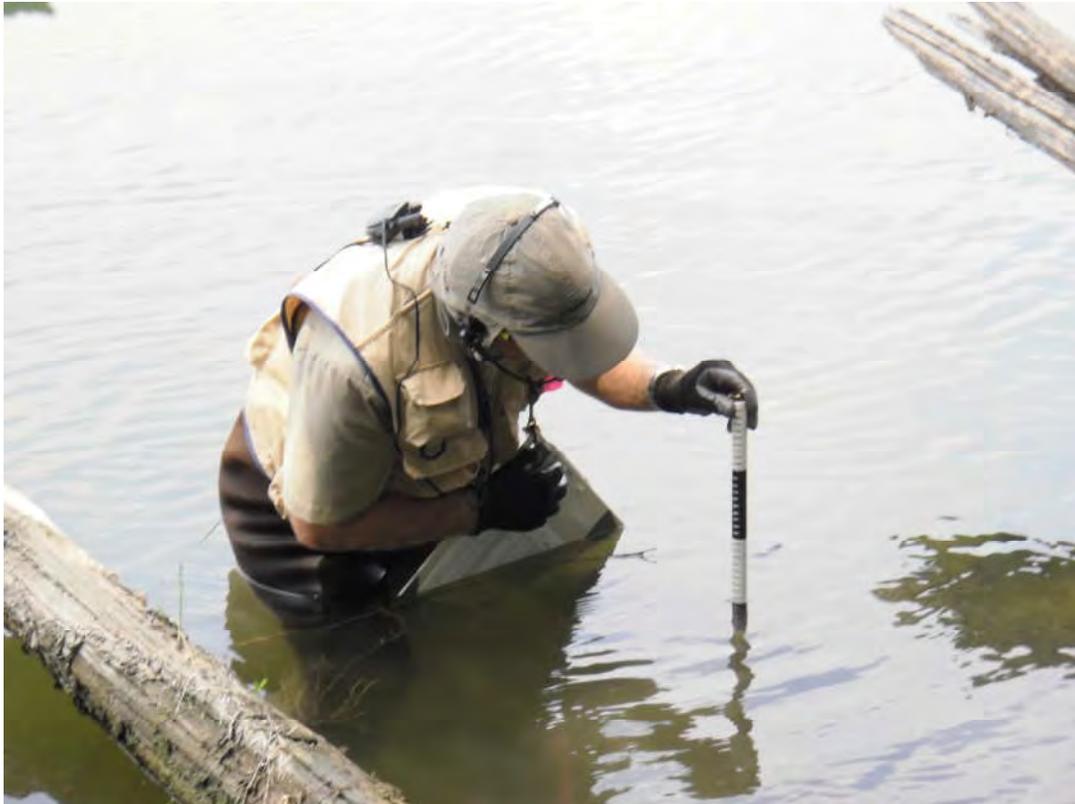
Fig 3: Measuring the elevation of a submerged log (Photo: M Holley)

based display of 3 days worth of real-time data. An initial value was determined by measuring the position of the upper surface of each log relative to water level (Fig. 3). Time of day was noted regularly, and both data were entered into a spreadsheet. Later, the lake level data were downloaded (Appendix F), and the value corresponding to the time of measurement was entered

for each log. By adding the observed elevation of the log to the gauging station data, and adding it to LWD, an elevation for each log was calculated, with accuracy to a tenth of a foot (3 centimeters). This was done by embedding a conversion formula in the survey data spreadsheet, (Appendix E). The discovery of a bronze benchmark of known elevation attached to the Jefferson Avenue Bridge, will simplify this measurement in the future.

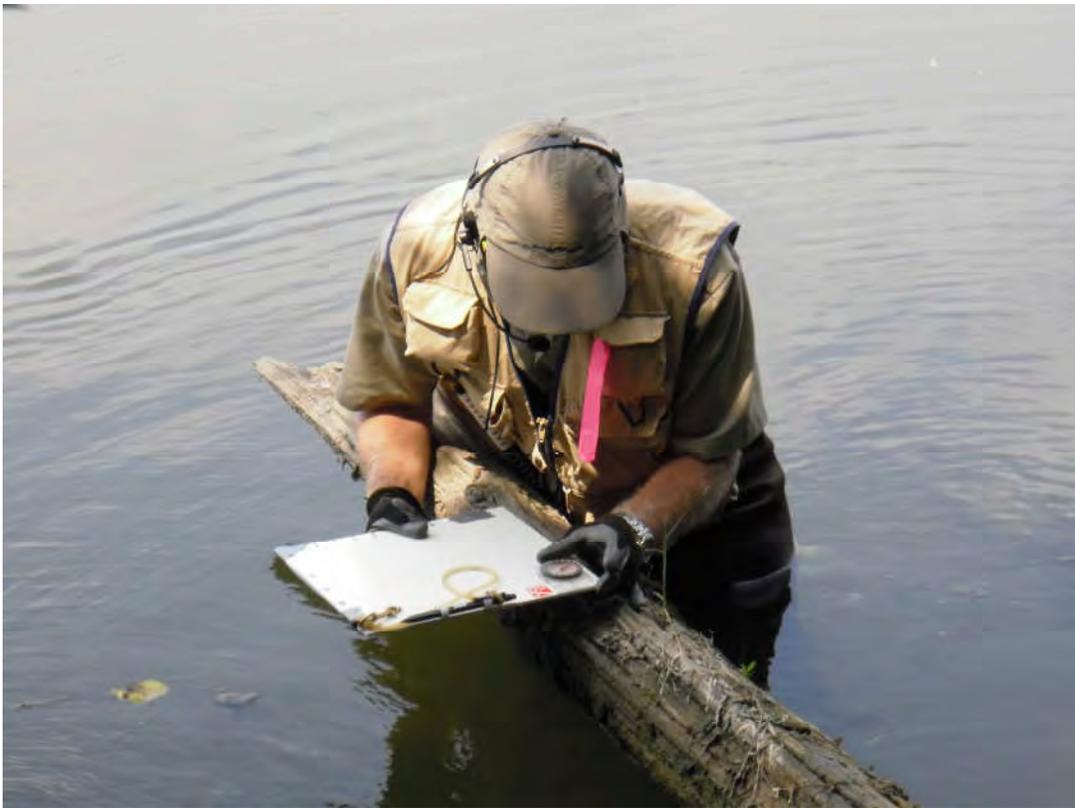
Fig 4: Measuring orientation of a log using the NAS dive slate (Photo: M Holley)

All but a few of the logs lie roughly parallel to each other, evidencing the deposition of the feature at the time of initial site formation. The orientation of the axis of the logs was measured using the compass on an NS dive slate (Fig 4). Orientation generally ranged between 117° to 120° (Magnetic), which corrected to 110° to 113° (True). Significant deviations usually occurred among logs that were emergent (normally above waterline).

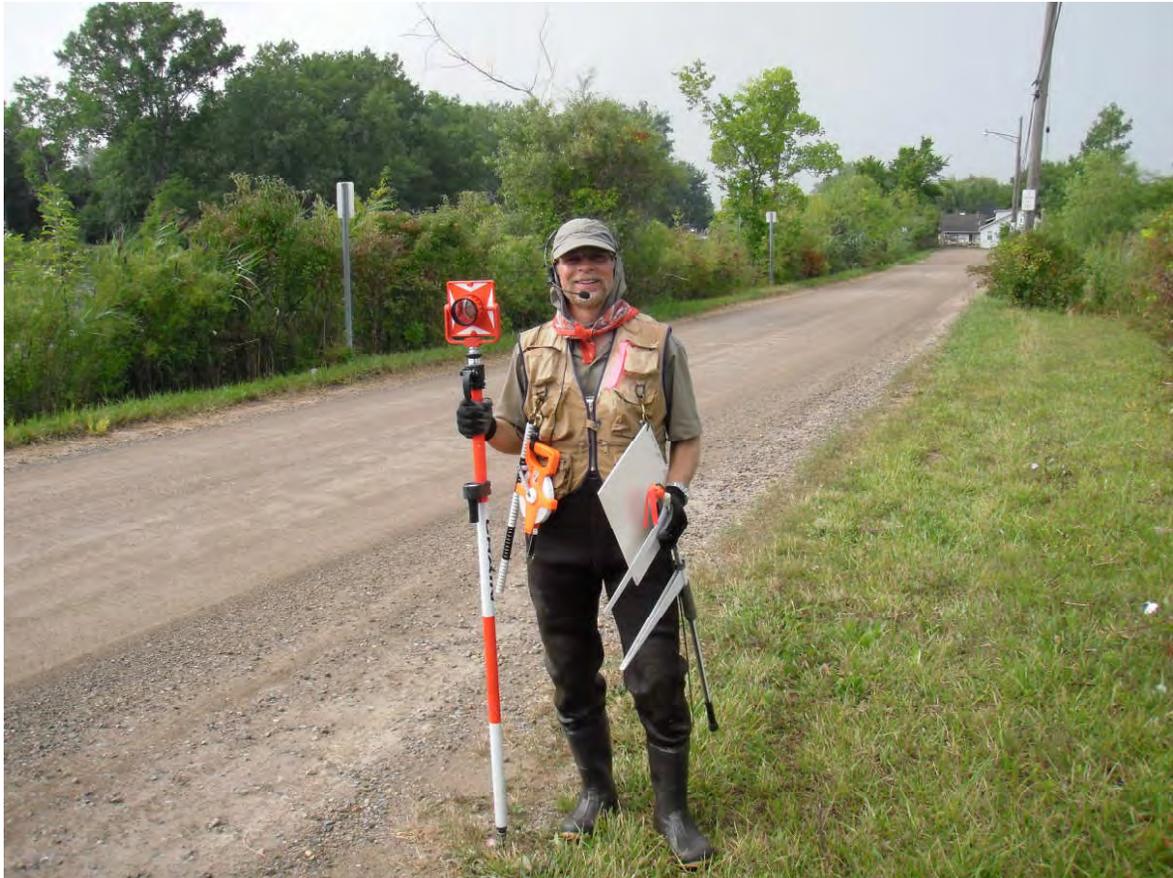
Fig 5: Spotter with prism pole, radio and other measuring tools (Photo: M Holley)

Position was plotted using an EDM, operated by NAS senior instructor Dr. Mark Holley. A total of 209 endpoints were plotted in a single session on August 16, 2009. Communication between the spotter and the EDM operator was facilitated using 2-way radios with a hands-free headset on the spotter's unit (Fig 5).
